Name of Dam: Buffalo River No. 2

Location: Amherst County, State of Virginia

Inventory Number: VA 00912

PHASE I INSPECTION REPORT
NATIONAL DAM SAFETY PROGRAM

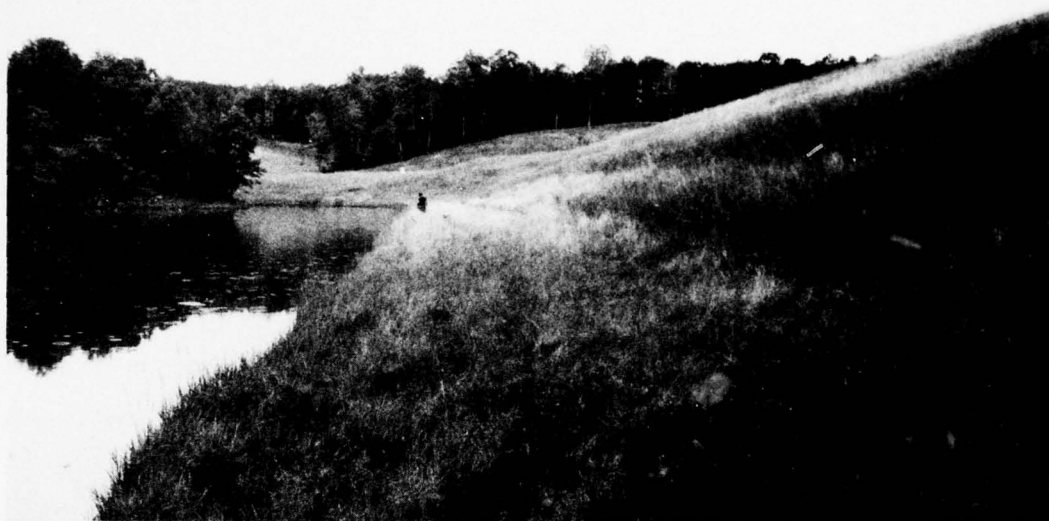
PHOTO 1. Upstream Face of Dam Looking Toward Approach to Emergency Spillway

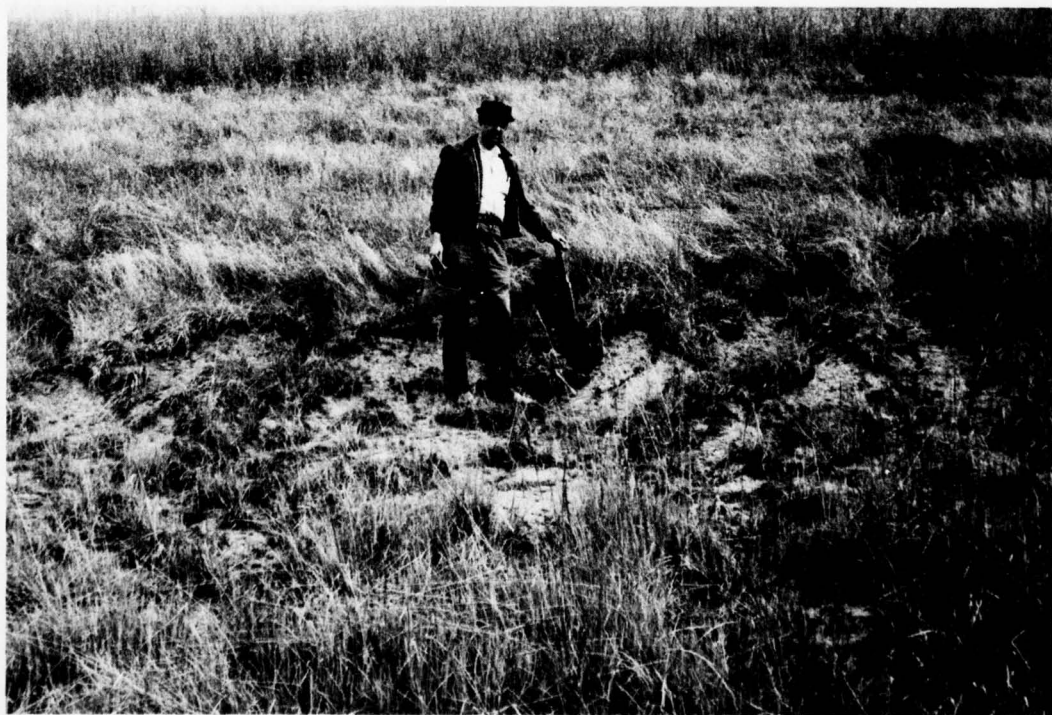
- 6.2.1 Visual Observations: No evidence of movement, such as tension cracks or bulging of the embankment, was noted. There was some erosion and slight sloughing located 50 feet from the left abutment in the soft wet clayey silt (100 foot by 20 foot area) just above the toe of the upstream slope. Several tree branches are imbedded in the soil. There are minor erosion gullies on the downstream slope. Otherwise, the embankment is in good condition with no visible seepage on the downstream slope.

The deficiencies in the riprap on the downstream channel and the slight sloughing on the upstream slope do not affect the stability of the embankment.

PHOTO 2. Sloughing and Erosion Area Near Upstream Left Abutment

- 3.2 Evaluation: Generally, the dam and appurtenant structures are in good condition. The wet sloughing soil and imbedded branches near the left abutment of the upstream slope should be removed and replaced with compacted fill. The eroded bare areas on the slopes should be manually graded and seeded. It is recommended that the uncovered steep bank in the stilling basin be regraded and stone riprap replaced. The small tree near the impact basin should also be removed. Loose branches on the rock gutters and driftwood on the upstream shore can be removed as part of the regular maintenance program.

- 1) Remove wet sloughing soil with imbedded branches near the left upstream abutment and replace with compacted earth.
- 2) Grade and seed eroded bare areas near the bench on the downstream slope. Also, grade and seed erosion gullies in the vicinity of the rock gutters at the left downstream abutment and right upstream abutment.
- 3) Seed and fertilize areas with dead grass.
- 4) Remove driftwood on shoreline of dam and fallen branches from rock gutters.
- 5) Place additional stone riprap on the banks of the stilling basin where discharge has washed it away.
- 6) Remove small tree from stone riprap adjacent to left wing wall of impact basin.
- 7) Fill and seed erosion gullies in discharge channel of emergency spillway.
- 8) Install a staff gage to monitor reservoir levels above normal pool.

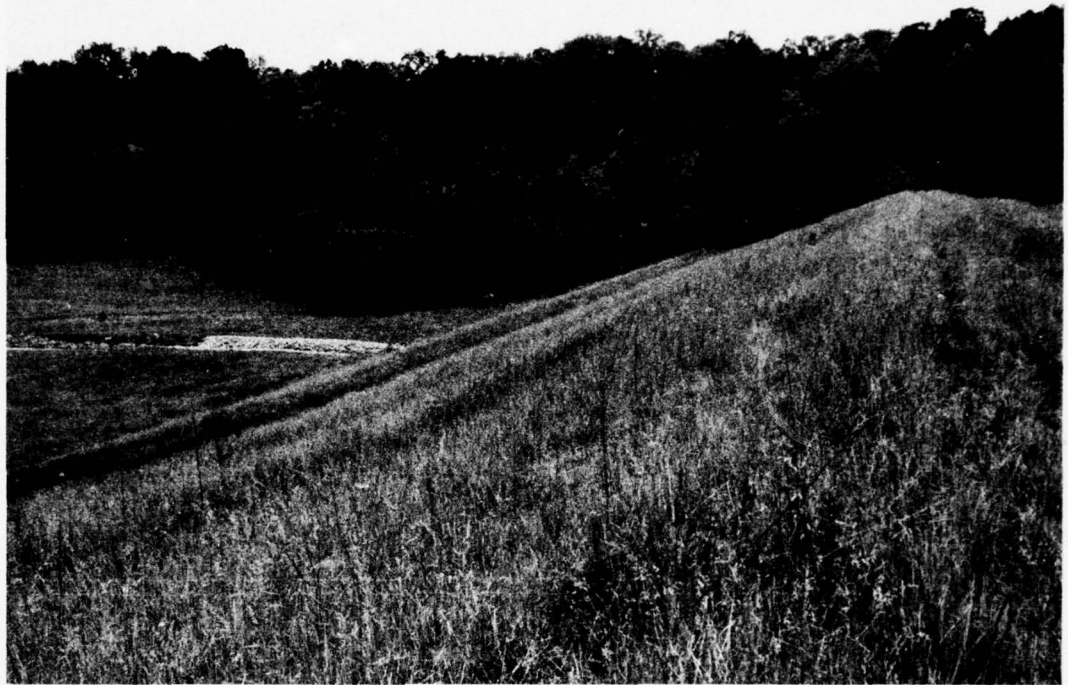
No seepage was observed on the downstream slope.

PHOTO 3. Downstream Face of Dam

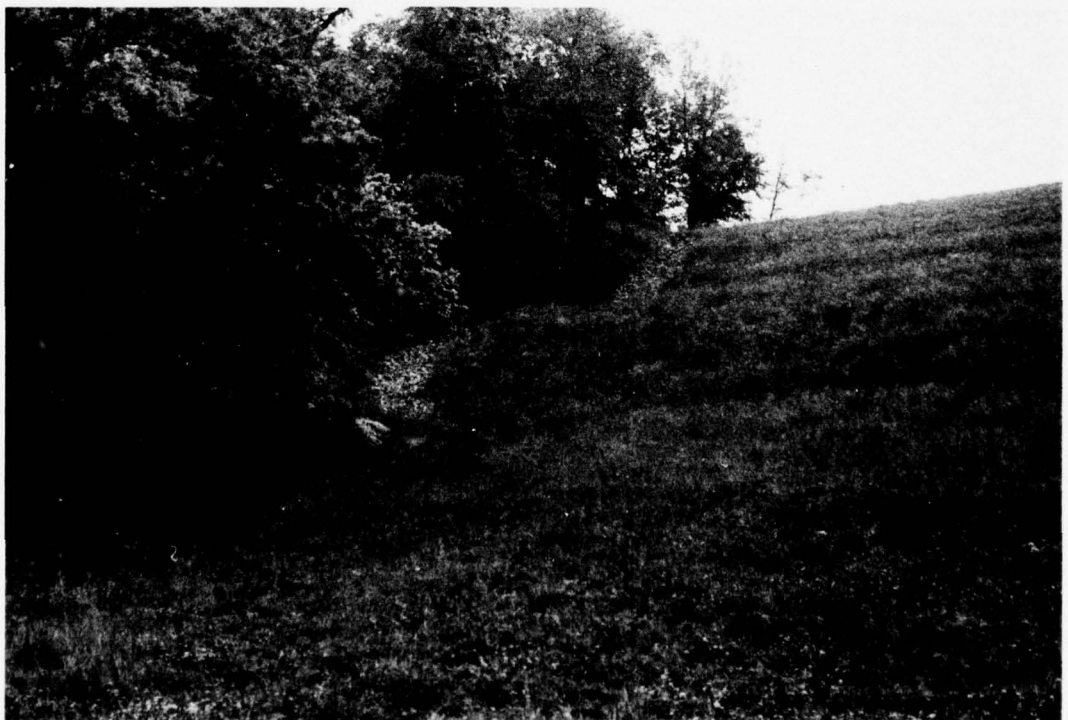
PHOTO 4. Junction of Downstream Embankment and Right Abutment

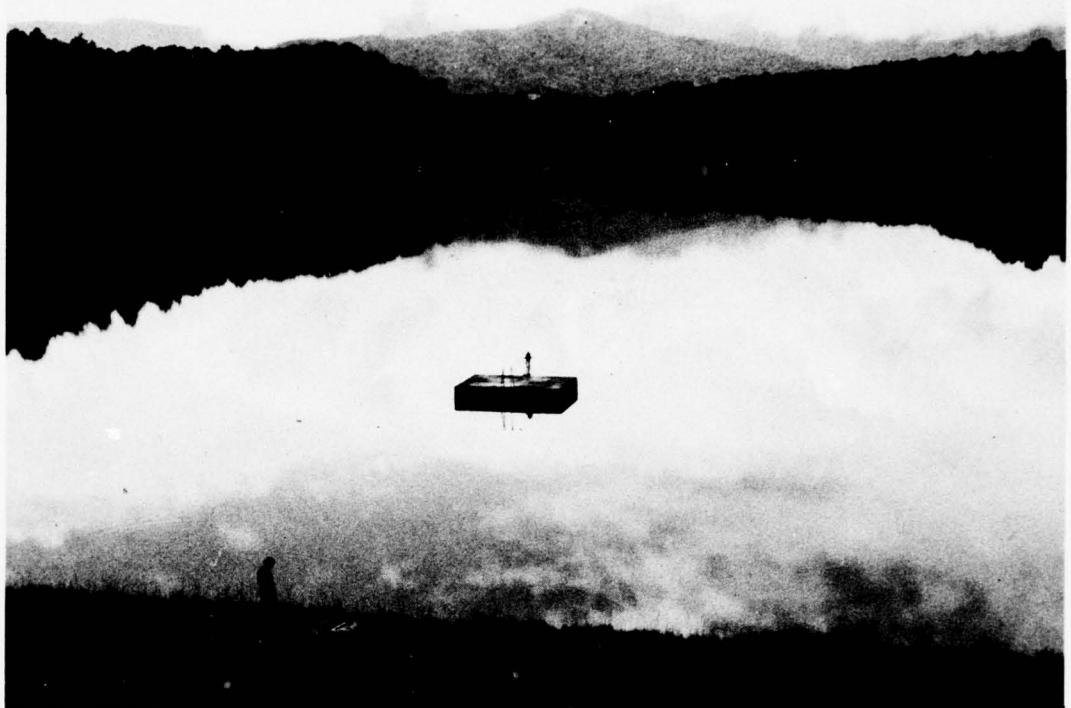
PHOTO 5. View of Riser and Reservoir from Crest of Dam

- 3.1.4 Reservoir Area: No serious deficiencies were observed in the reservoir area. A staff gage should be installed in the reservoir to monitor water levels above normal pool.

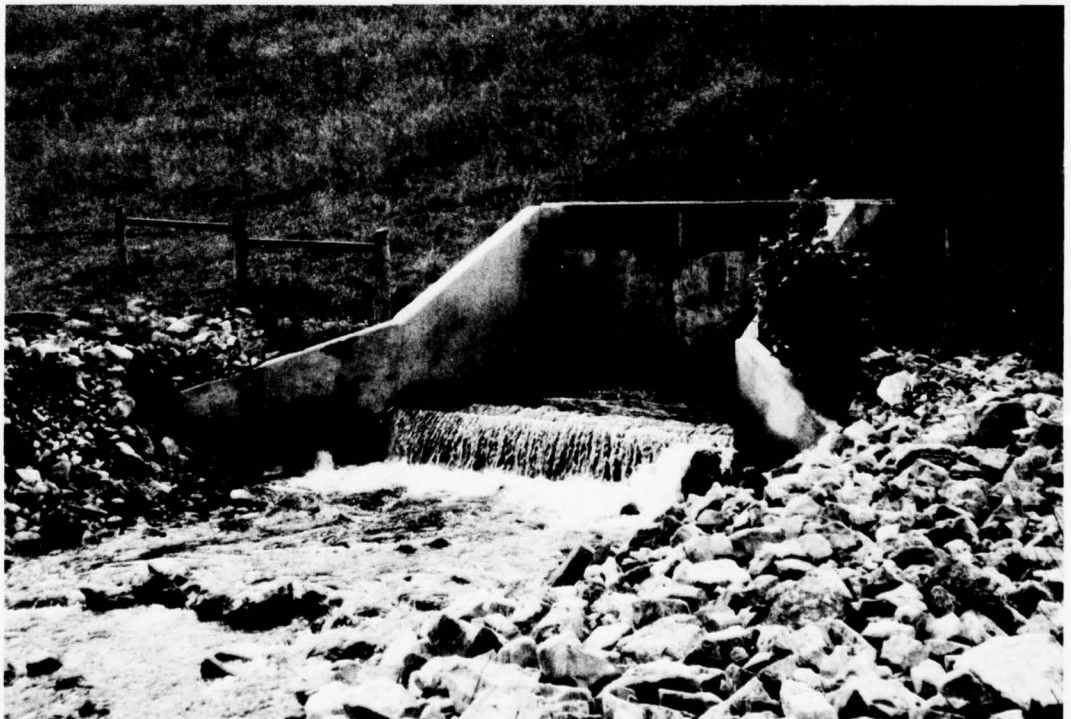
- 3.1.3 Appurtenant Structures: The principal spillway was functioning satisfactorily (see Photo 6) and no structural deficiencies were found on the appurtenant structures.

PHOTO 6. Outlet of Principal Spillway, Impact Basin and Riprap-Lined Channel

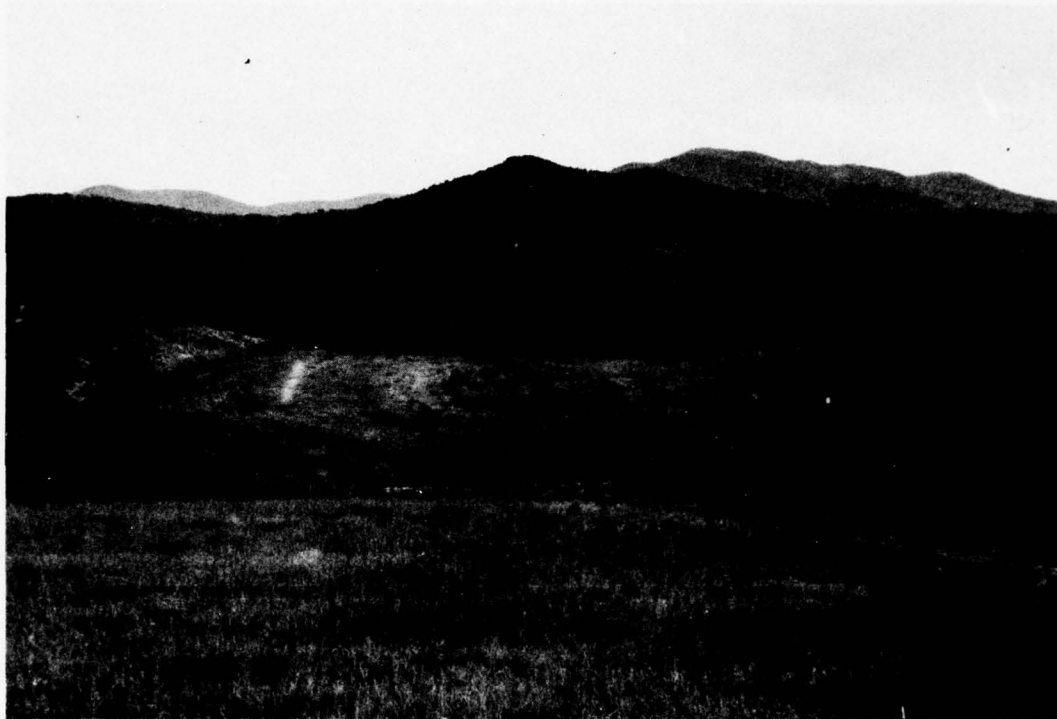
PHOTO 7. View of Emergency Spillway and Left Abutment Looking Downstream

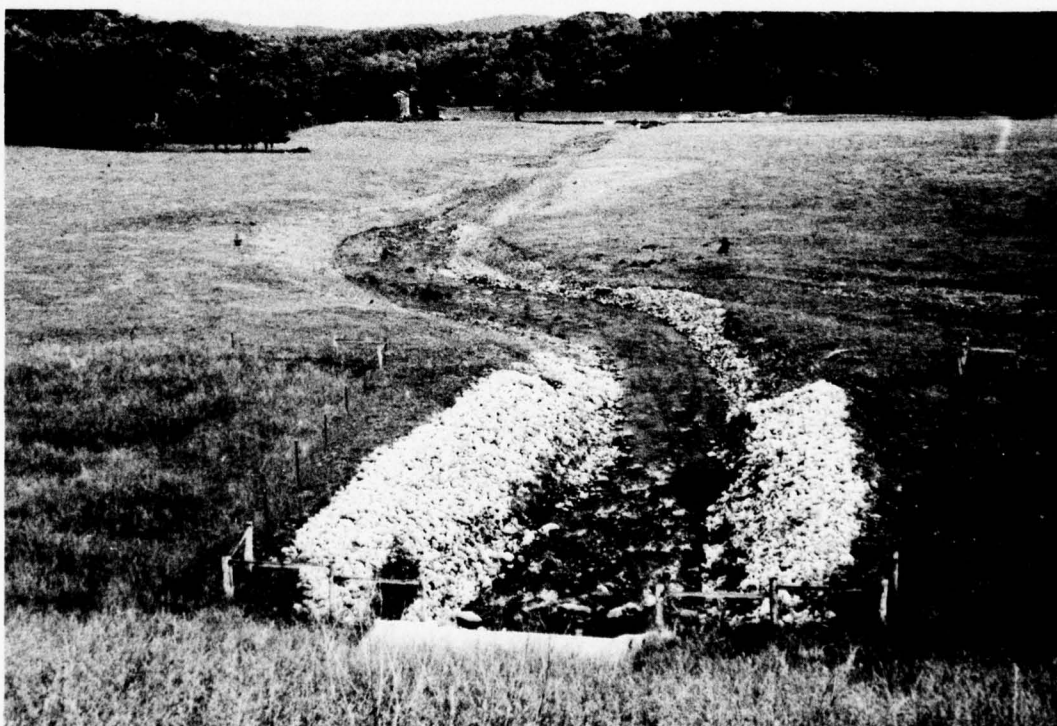
PHOTO 8. Downstream Area with VA Route 610 and Farmhouse in Background
